**In-Flight Electrical System Failure  
and Loss of Control  
Jet Express Services  
Raytheon (Beechcraft) Super King Air 200,  
N81PF  
Near Strasburg, Colorado  
January 27, 2001**

**NTSB/AAR-03/01  
PB2003-910401  
Notation 7358A  
Adopted January 15, 2003**

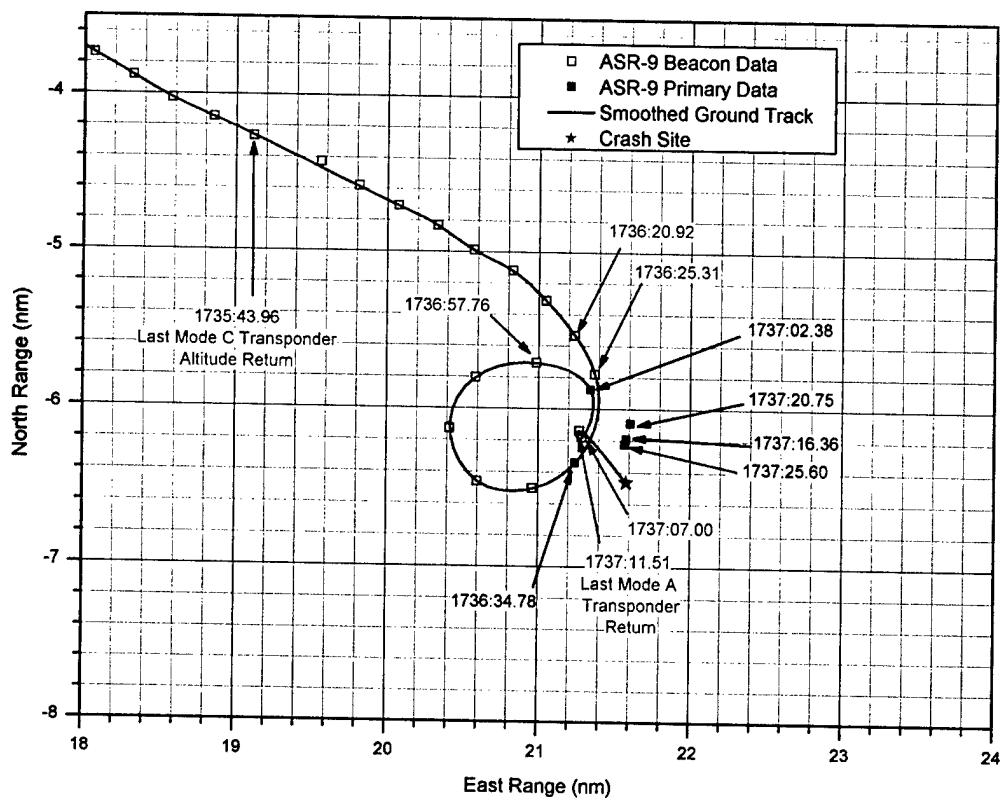
Note: Airport surveillance radar-9 (ASR-9) primary data are reflected radio signals. ASR-9 primary data returns were received until about 1737:26, about 14 seconds after the last mode A (beacon data) return. The distances shown are relative to the ASR-9 radar site at Denver International Airport.

Figure 1. Radar data for the last 2 minutes of the accident flight.

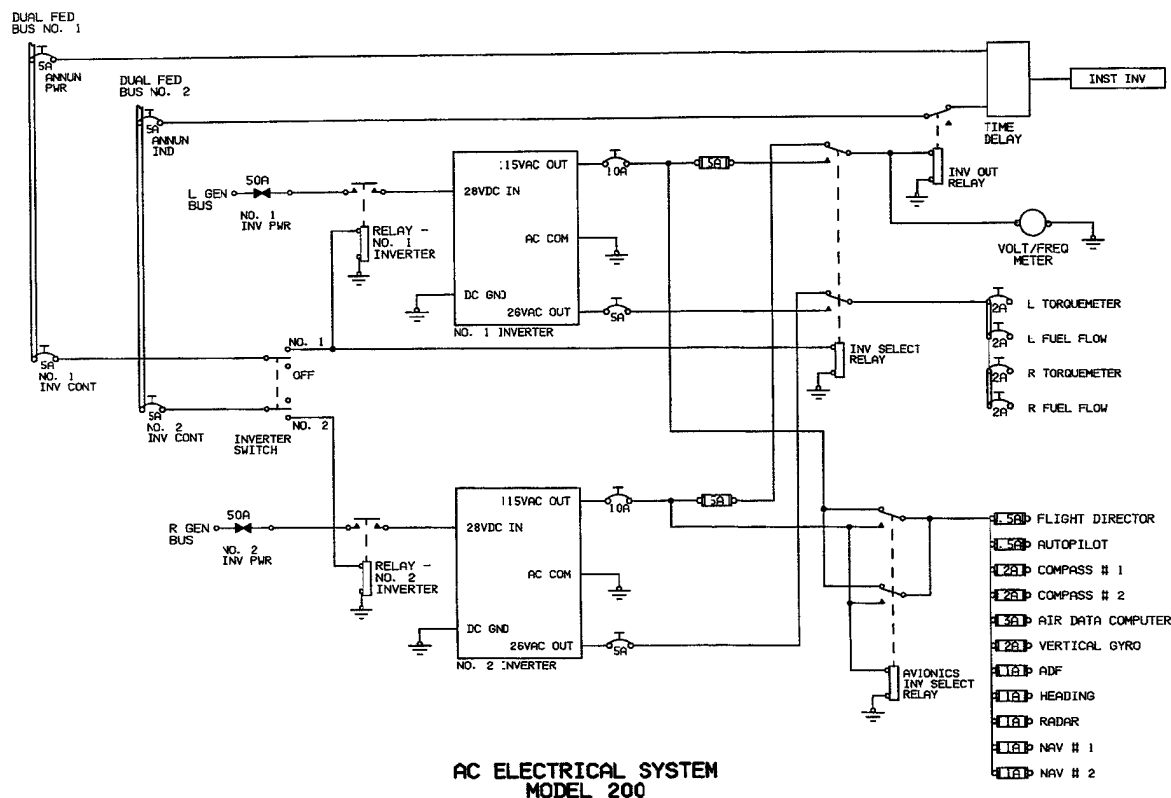
**Figure 2.** Schematic of the King Air 200 a.c. electrical system.

Third, the King Air 200 electrical system schematic indicates that, if at least one of the inverters is operational, no a.c. power is present at the volt/frequency meter, and d.c. power is available to the inverters, then one of three components—the inverter selector switch, the inverter select relay, or the avionics inverter select relay—could produce an a.c. power electrical system failure (see figure 2). Thus, all three components are potential sources of single-point failures in the electrical system. None of these items was recovered from the wreckage.
